Case Study: Resolving Partial Discharge Issues within a Combustion Turbine Generator

Theadora Lybarger – PSE Electrical Engineer
Chris Brown- PSE Electrical Engineering Supervisor
David Brown – PSE Plant O&M supervisor, Whitehorn Generating Station

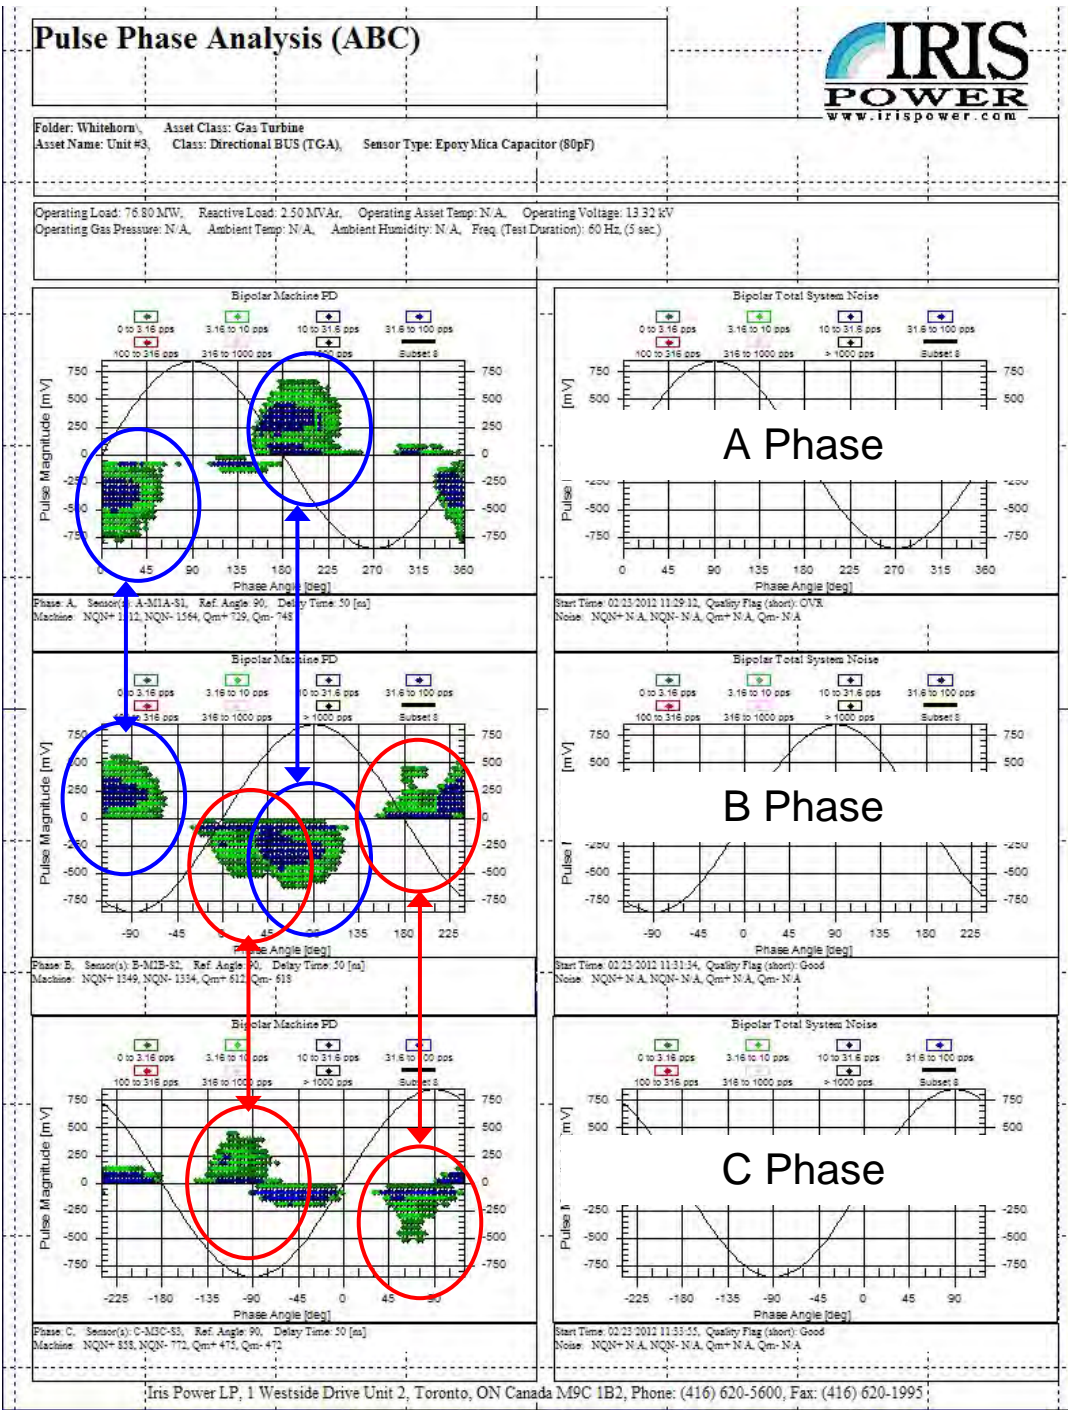
On February 23, 2012 a Partial Discharge (PD) Analysis was performed on Whitehorn Unit 3 by personnel from PSE's Plant Technical Services (PTS), the generation engineering group. The test revealed very high levels of PD both in pulse amplitude (Qm) and quantity of pulses (NQN). Qm levels were greater than 95% of similar units when compared against the 2011 IRMC Partial Discharge Testing Progress Report. Though PSE rolled out their PD testing program at all of their Combustion Turbine facilities in 2010, including Whitehorn, this was the first analysis performed on the Unit due to limited operations. Results showed PD activity was largely confined to two distinct locations, between phases A and B, and between B and C, as can be seen in the reflected clusters of activity circled and correlated in Figure 1. The location of the pulses with respect to each 60 Hz waveform (phase) of the generator, as shown below, pointed to the endwinding as the likely source of the PD activity.

Figure 1: ABC Plot Showing Phase to Phase PD

At this time Iris Power was consulted. They confirmed that the data indicated a condition which could lead to stator failure and should be addressed. Additionally, this type of phase-to-phase discharging was likely due to either contamination between phases resulting in electrical tracking or phase-to-phase discharging due to close proximity between endwinding coils.

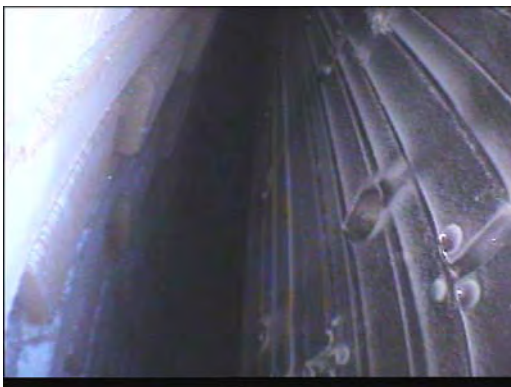
An articulating video borescope was secured and the Unit was taken out of service to inspect the endwindings. It proved to be a difficult task both to squeeze far enough inside the generator housing to allow the borescope to reach the endwindings, and to know the location of the optical tip with enough confidence that the entire area was adequately examined. It was evident that both the stator and rotor were caked with an oil and dirt residue. The photo below on the left was typical for the turbine end of the generator. The collector end was also very dirty, though not quite as bad.

Figure 2: Drive End with Dirt and Oil

As expected, both ends had more dirt and oil on the lower half which was inaccessible, and thus not cleaned, during the 2008 outage. White PD residue was not observed on either end but this was believed to be due to the limited access and significant amount of dirt obscuring much of the winding. See Appendix I for additional borescope photos.

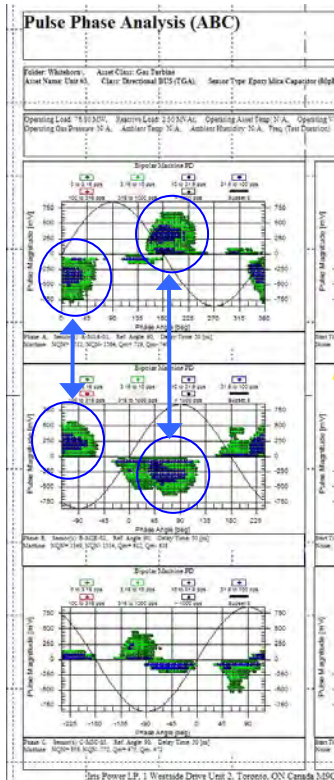
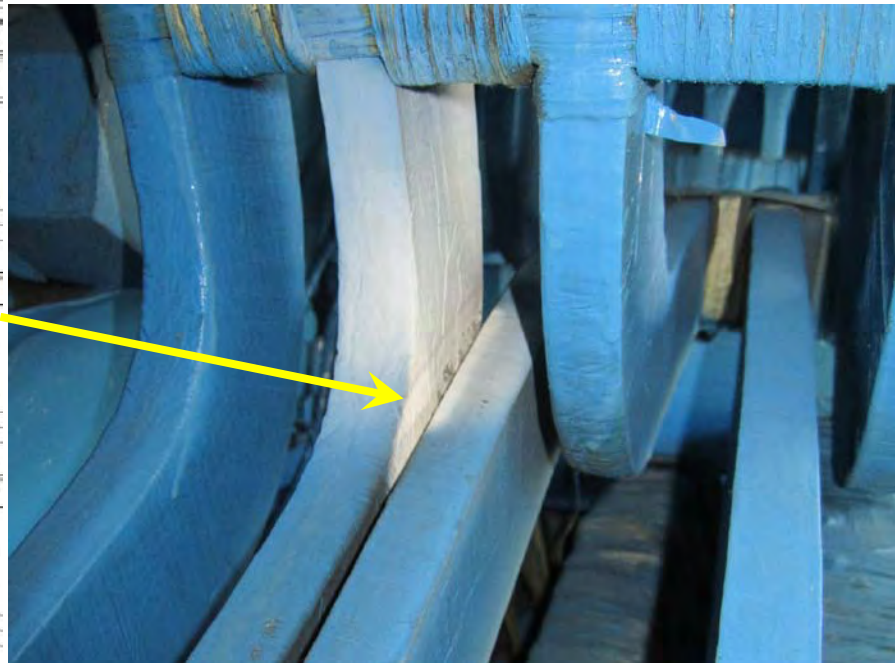
When the generator vendor arrived on site on April 19th the mechanical vendor had already completed the CO₂ blasting, potentially removing some of the evidence of partial discharge damage. However, the PD activity was still obvious as the most significant damage was between phase connection rings on the collector end of the machine, as shown in the following photos.

Figure 4: PD between A and B Phase, Connection Ring Bus

The PD activity in the endwindings was as significant as anticipated based on the test results. It appeared that the root cause was either an original manufacturing issue or a transient electrical event during operation which deformed the winding. In either case sections of the buses were too close together. Though it was easy to find it was not something easy to correct.

The optimal fix for any corona damage caused by insufficient spacing, especially where the bars are almost touching for an appreciable distance (Figure 6), would be to clean the area, repair any damage to the insulation and increase the distance between them. Unfortunately, the latter wasn't feasible because bending the bars to separate them could result in distortion of the winding elsewhere or cracking of the insulation. Instead, after the bars were cleaned and corona damage repaired, a non-conductive barrier was created using a high dielectric silicon RTV in the areas of closest proximity. After the RTV cured the endwindings were coated with an Anti-Corona paint to discourage future discharging between phases.

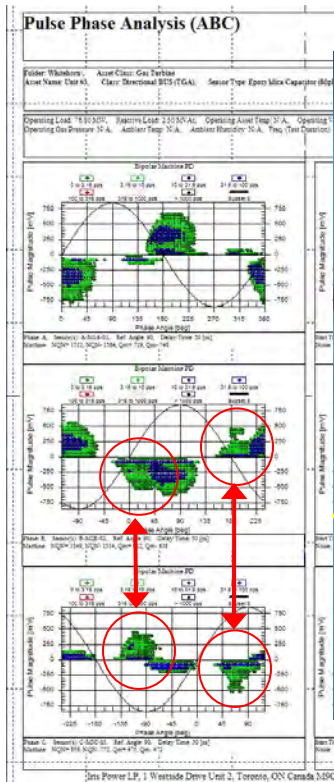
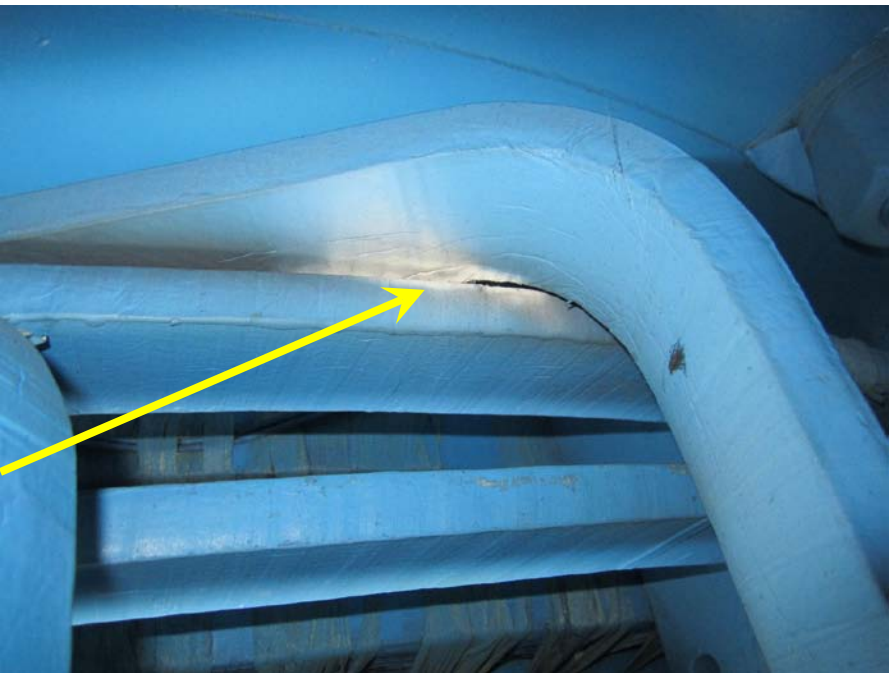
Figure 5: PD between B and C Phase, Connection Ring Bus

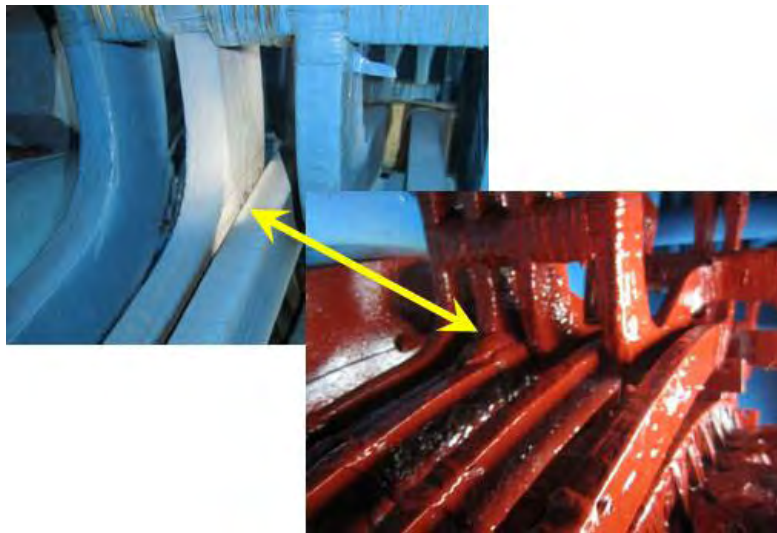
Figure 6: Before and After Repairs of Damage between A and B Phase

The Phase A to B PD levels were reduced by 25-30% in Qm and more than 50% in NQN (see blue circled sections in Figure 11.) Although the damaged area was repaired it is not surprising the winding still shows discharge coupling between these two phases because the two ring bus sections (A and B) are still in close proximity ($\frac{1}{4}$ " to $\frac{1}{8}$ " of separation) and parallel to each other for several inches. As mentioned before it was not possible to physically move the ring bus sections apart without causing other damage, therefore, the section where the buses were the closest (the white powder in Figure 4) was reinsulated. Because the adjacency remains beyond the reinsulated section, moderate PD activity is still present from this location. This should not be an issue; however, it should be tracked during future PD testing. Figure 6 shows the repair.

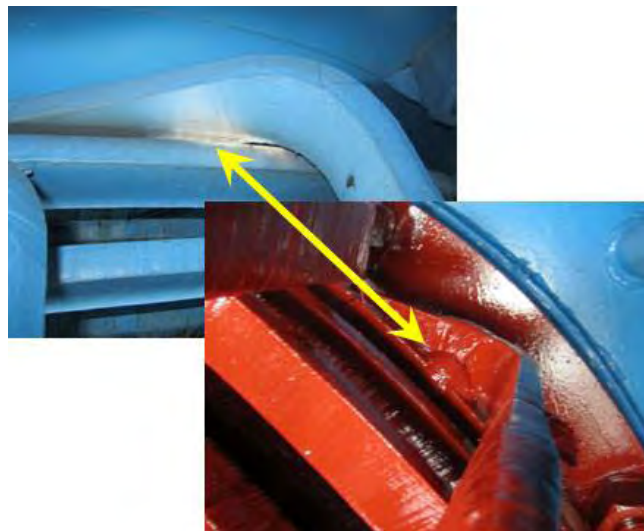
Figure 7: Before and After Repairs of Damage between B and C Phase

The Phase B to C PD levels were almost completely eliminated with the repair. These levels decreased more than 75% in both Qm and NQN. The remaining levels are typical background values; see red circled sections on the right side of Figure 12. This makes sense as this phase coupling was a specific point where the two ring buses (B and C) came in close proximity. Refer to Figure 7 for before and after photos of this repair.

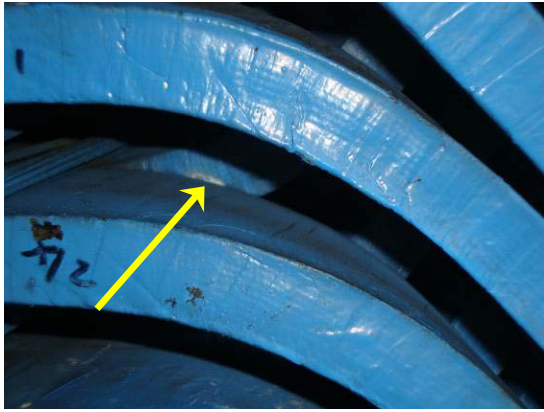
Smaller areas of corona damage were also discovered between some top and bottom bars at the slot exit area on the collector end as well as between adjacent phases on the turbine end as can be seen below. These locations were cleaned and repaired in a similar fashion.

Figure 8: PD between Top and Bottom Bars

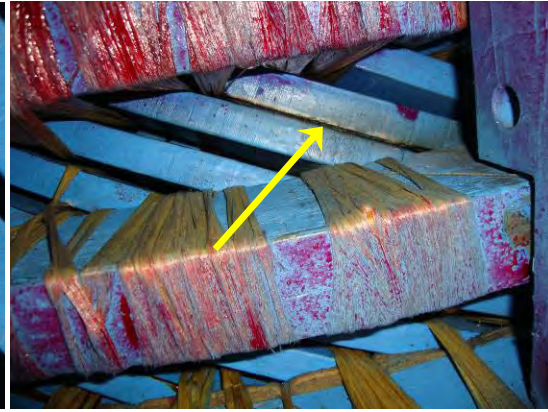
Figure 9: PD between Adjacent Phases

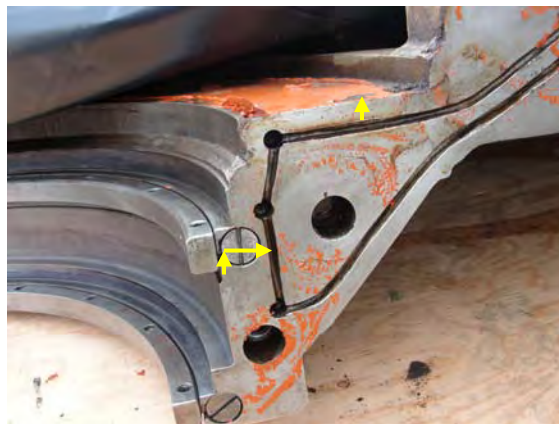
The exceptional level of contamination discovered during the pre-outage borescope inspection indicated there was an oil leak. During disassembly special attention was paid to the endshields and oil deflectors to find the oil leak path. When the turbine end upper endshield was removed a groove intended for pumping sealant for Hydrogen cooled generator applications was discovered. Since this unit was not Hydrogen cooled the groove was left empty during initial installation. The open groove, in addition to the joint not being closed tightly, allowed oil to flow into the generator.

Figure 10: Upper Endshield Horizontal Flange - Arrow Shows Oil Path to Generator from Bearing Seal Cavity

The OEM factory endshield installation procedure was obtained and followed during reassembly which should eliminate future oil leakage and limit the amount of contamination observed at the next outage.

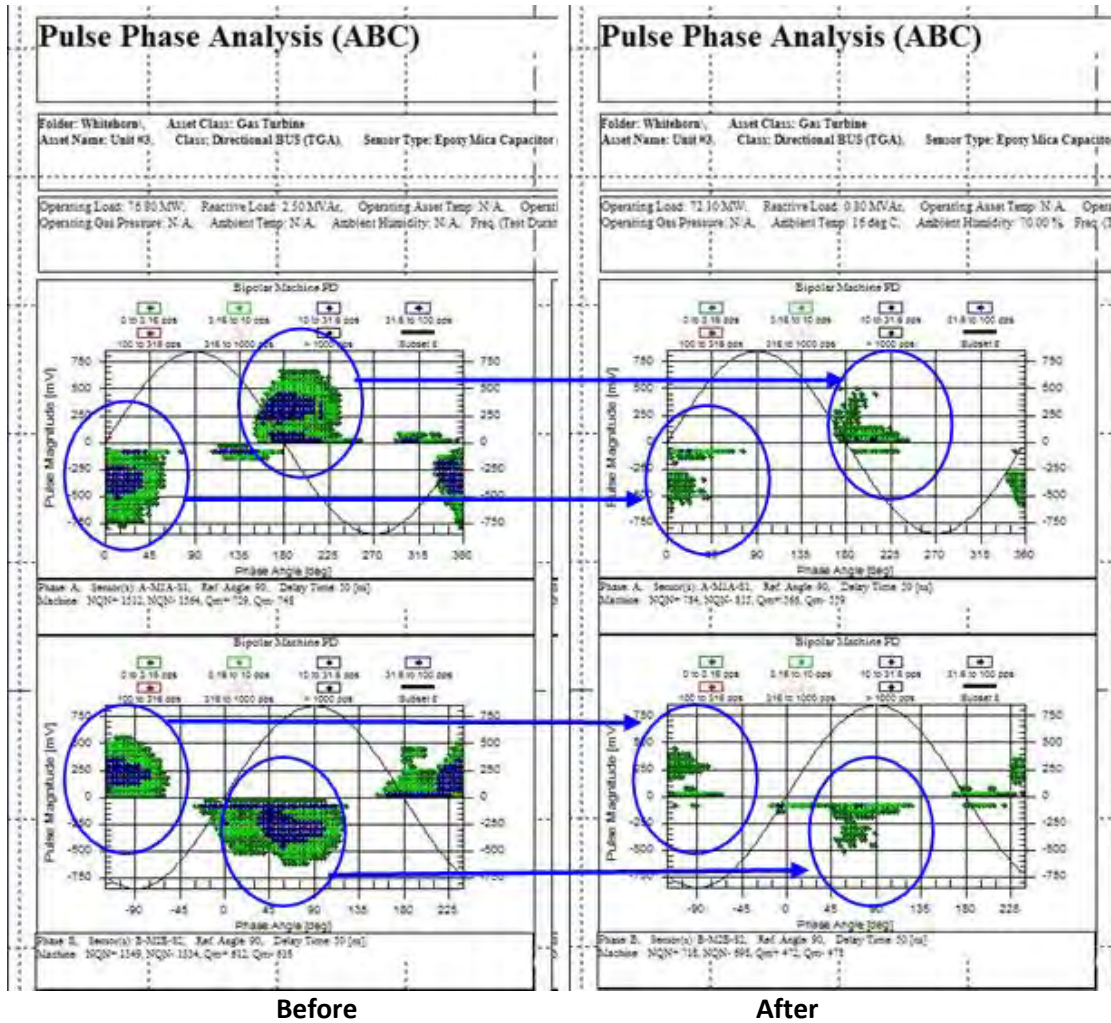
Figure 11: Before and After ABC Phase Plot Showing Decreased A to B Phase PD Levels

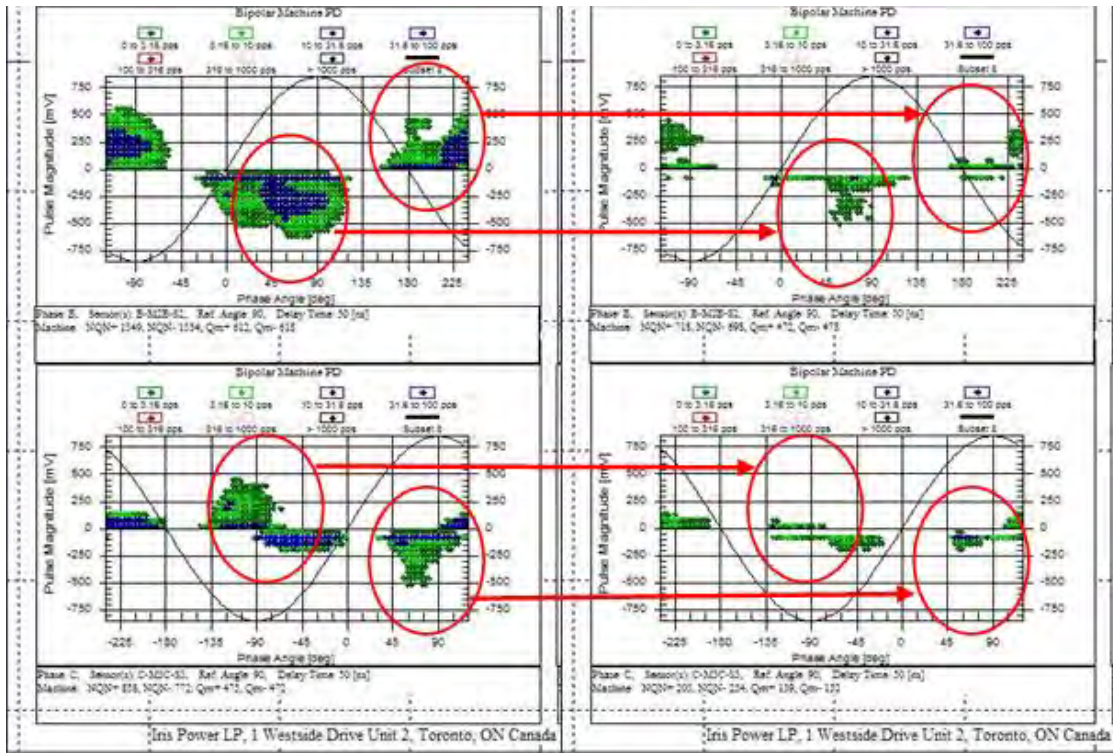
Before **After**
Figure 12: Before and After ABC Phase Plot Showing Decreased B to C Phase PD Levels

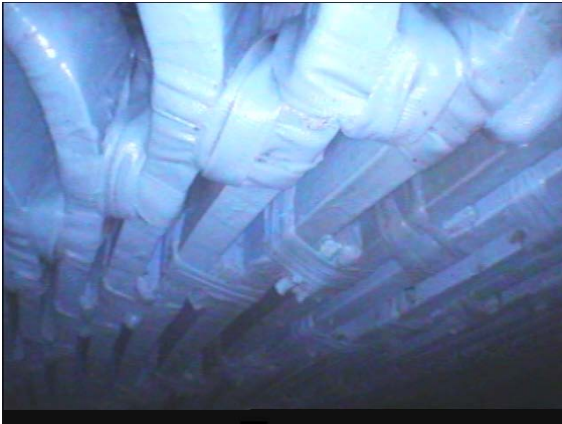
Figure 13: Non Drive End - Clean Top Endwinding

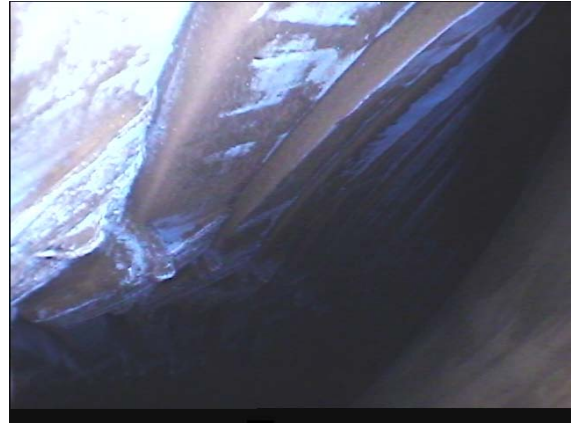
Figure 16: Drive End - Lower Endwinding with Dirt and Oil

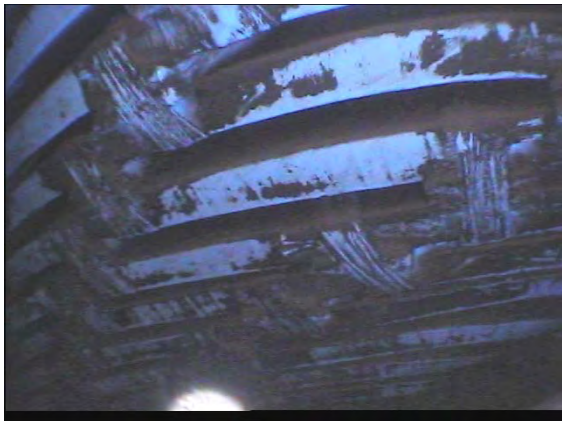
Figure 14: Drive End - Lower Endwinding with Dirt and Oil

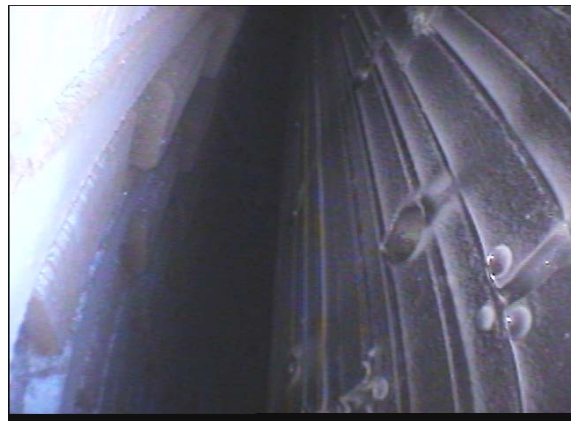
Figure 17: Drive End - Air Gap with Dirt and Oil

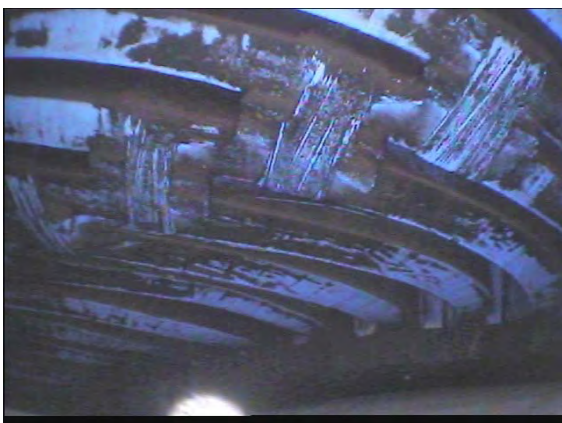
Figure 15: Drive End - Lower Endwinding with Dirt and Oil

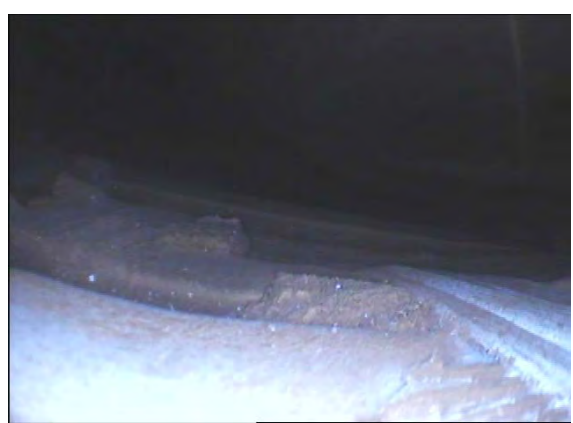
Figure 18: Non Drive End - Lower Endwinding with Dirt and Oil
