# Impact of Slot Discharges and Vibration Sparking on Stator Winding Life in Large Generators

**Key Words:** slot discharge, vibration sparking, spark erosion, stator winding

*Slot discharge has long been known to be a common failure mechanism of stator winding insulation. Less well known is the fact that vibration sparking can result in very rapid failure, and has many of the characteristics of slot discharge.*

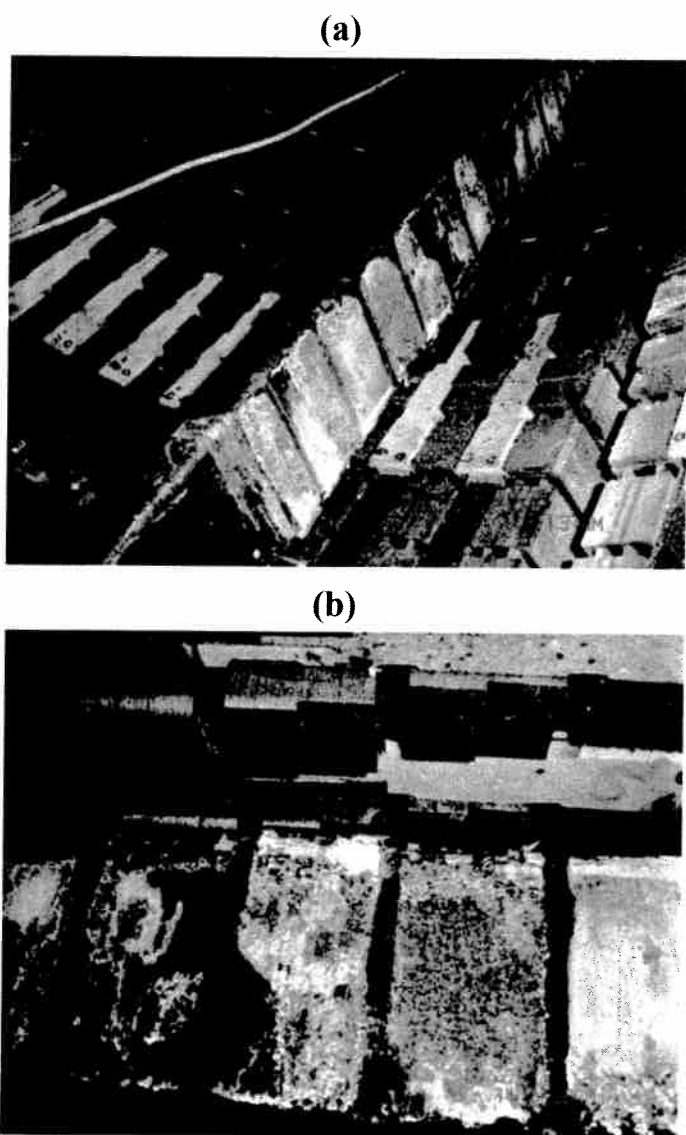
The air-cooled turbine generator shown in Figures 4 and 5 was rated about 160 MW, 18 kV and was manufactured in 2001. This unit had been operating for about 30,000 hours. Such VS has been noted on several bars in the stator. This particular stator also appeared to have slot discharge caused by loose bars.

Figure 5. Bars being removed from an air-cooled turbine generator suffering from both VS and the loose coil form of slot discharge.

Because VS tends to be an aggressive, relatively fast-acting phenomenon, stator rewind may be the only viable option.

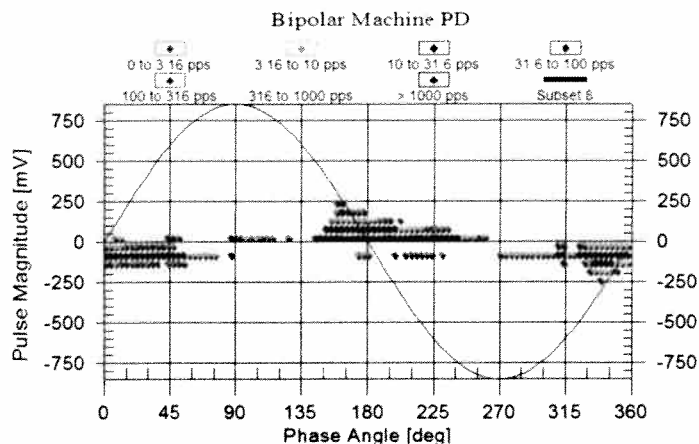
Figure 6 shows the pulse pattern obtained with an on-line PD monitor on an air-cooled machine that is known by visual examination to be experiencing both advanced VS as well as the loose bar form of slot discharge. Note the pulse pattern is shifted about 90 degrees to the left of the normal position for pulses caused by slot discharge [1]. Such a "left shift" in a pattern was observed on another machine with suspected VS. However, it is still too soon to determine if this phase shift is a normal aspect of VS. Note that because VS does involve abrasion of the insulation and slot conductive coating, VS in bars operating at high voltage will eventually produce PD as a symptom.

Figure 6. On-line “PD” detected by means of 80 pF capacitive couplers mounted on the turbine generator terminals.
