STATOR ENDWINDING VIBRATION IN HYDROGEN COOLED GENERATOR

301.2MVA, 18kV, 2-pole, Hydrogen-cooled Generator

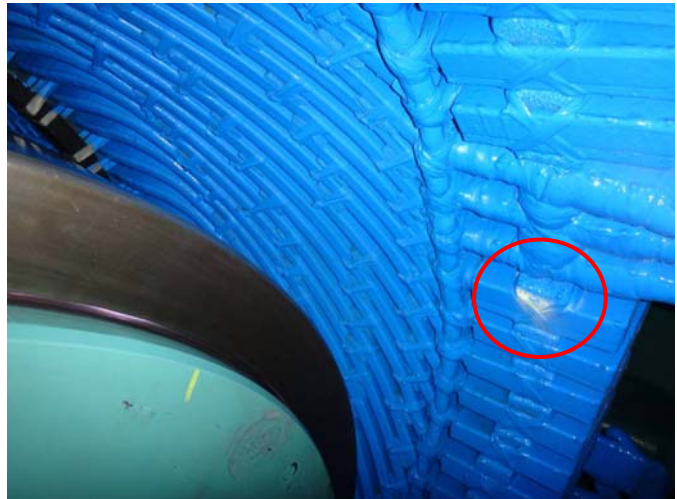
Figure 1 – Dusting Between Felt Block and Stator End Cap

- visual inspections showed dusting (*See Figure 1*) near one of the phase connections being monitored in the 5:00 position

Although dusting may not be cause for immediate concern it is an indication of the stator bars relative motion at their supports and insulation abrasion. Copper does not have a distinct fatigue limit but may eventually fail from small stress amplitudes due to high cycle fatigue. The generator failure can occur from phase to phase faults or broken conductors. The vibration signature indicated the onset of excessive movement and was confirmed visually. The excessive movement should be limited to prevent failure and the vibration should be monitored continuously to indicate any change to the endwinding support system.

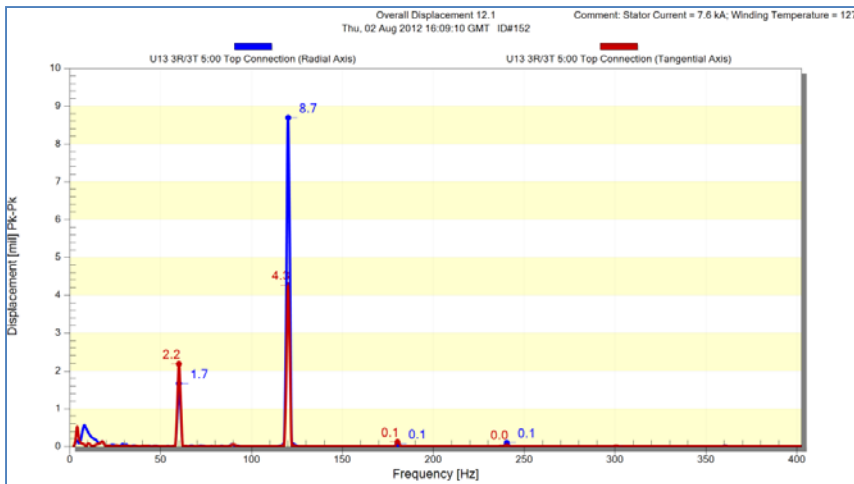
Figure 2 – Displacement Spectra

- on-line stator endwinding vibration data collected showed 12.1mils (308µm) pk-pk overall in the radial direction (*see Figure 2*)
- there is no consensus regarding acceptable endwinding vibration levels, but displacement higher than 10mils (250µm) pk-pk overall is concerning
