Case Study: Resolving Partial Discharge Issues within a Combustion Turbine Generator

Theadora Lybarger – PSE Electrical Engineer
Chris Brown- PSE Electrical Engineering Supervisor
David Brown – PSE Plant O&M supervisor, Whitehorn Generating Station

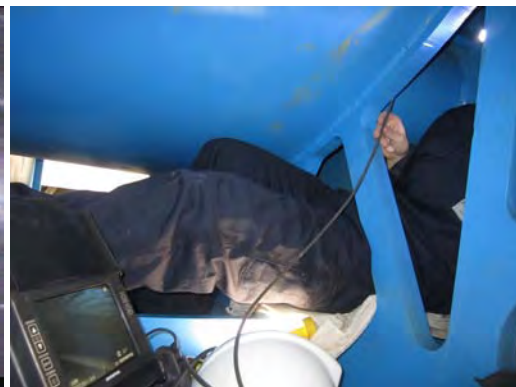
Figure 3: Borescope Access

As expected, both ends had more dirt and oil on the lower half which was inaccessible, and thus not cleaned, during the 2008 outage. White PD residue was not observed on either end but this was believed to be due to the limited access and significant amount of dirt obscuring much of the winding. See Appendix I for additional borescope photos.
