DETECTING TURN SHORTS IN ROTOR WINDINGS

A new test using magnetic flux monitoring

BY MLADEN SASIC, GREG C. STONE,
JAN STEIN, & CHRIS STINSON

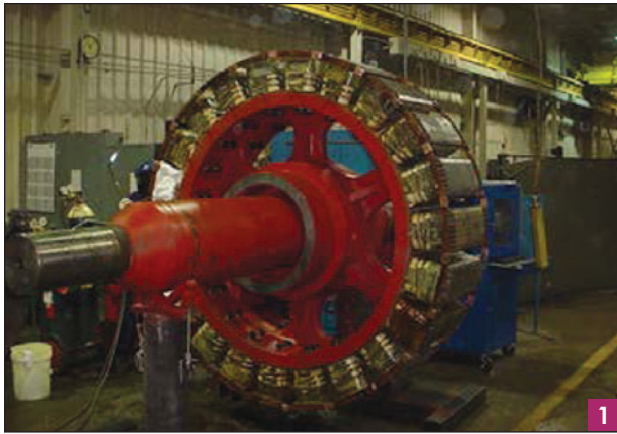
A rotor from a salient pole synchronous motor. (Photo courtesy of Iris Power.)

Most of the synchronous motors used in the air separation business have salient pole rotor windings with 4–26 poles. Each field pole is an electromagnet, and the rotor winding is made by mounting the poles in pairs on the rotor rim. The poles are then electrically connected to the dc supply (normally up to a few hundred volts) in such a way as to create alternating north and south poles around the rim. Each field pole consists of a laminated steel core, which looks rectangular when viewed from the rotor axis. Around the periphery of each pole core are the copper windings. Figure 1 is a photo of a rotor from a 20-pole salient pole synchronous motor.

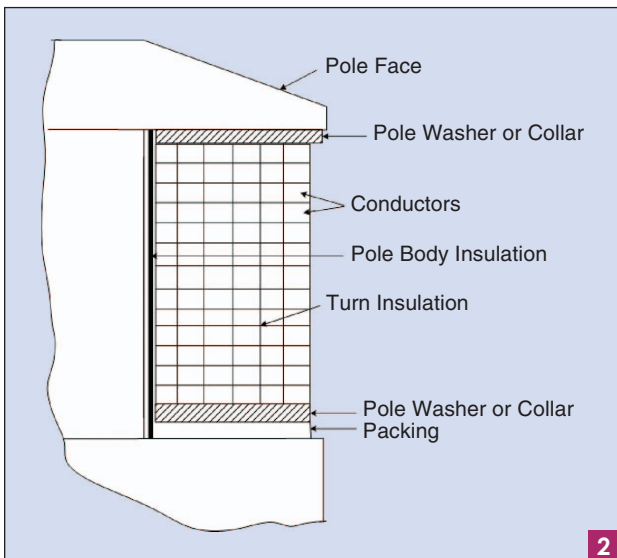
The multilayer wire-wound design.

There are two basic types of salient pole designs [1]. The older type of field pole design (still used on motors under 1,000 hp or so) is called the multilayer wire-wound type. In this design, magnet wire is wrapped around the pole (Figure 2). The magnet wire usually has a rectangular cross section, and many hundreds of turns are wound on the pole, several magnet wire layers deep. The turn insulation is the magnet wire insulation. Looking from the axial direction, the laminations are shaped to have a pole tip (which is the part of the rotor pole closest to the stator) to support the winding against the centrifugal force. Insulating washers and strips are placed between the magnet wire and the laminations to act as the ground insulation.

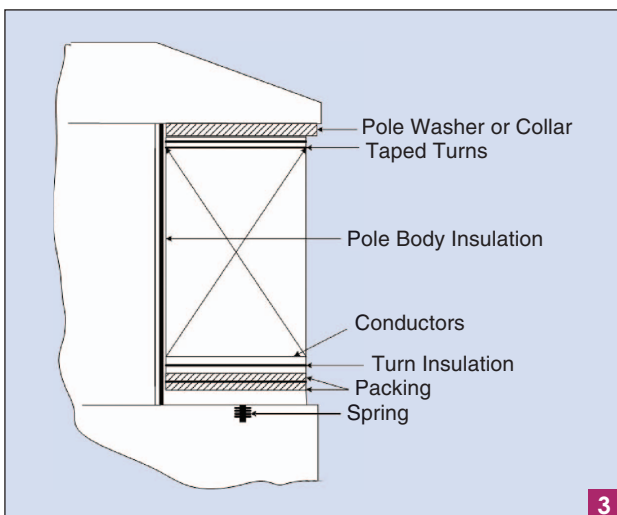
The copper strip-on-edge salient pole design.

For larger machines, the strip-on-edge design is favored since it can be made to better withstand rotational forces. In this case, a thin copper strip is formed into a picture-frame shape, so that the frame can slide over the pole laminations (Figure 3). Laminated insulating separators (made from epoxy glass laminates or Nomex materials) act as turn insulation to insulate each copper frame. On some copper frames, especially those near the pole face, an insulating tape may be applied to the copper strip to increase the creepage distance. The tape and separators form the turn insulation, and the copper picture frames are connected in series to make the coil. As with the multilayer design, the winding is isolated from the grounded pole body by insulating washers and strips (Figure 3). Often, the entire pole may be dipped in an insulating liquid to bond the various components together.

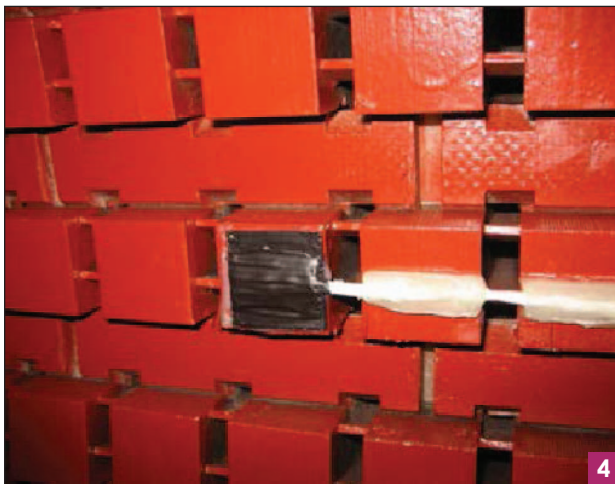
A flux probe (black) mounted on a stator core tooth, with connecting lead (white). (Photo courtesy of Iris Power.)

A new type of probe [5] has been designed to overcome the disadvantages of existing designs. The new probe is comprised of a number of printed circuit layers printed on a flexible base material. The flexible probe is designed for installation on a stator tooth. The very low profile of the installed probe enables its use on machines with small air gaps. In salient pole machines, it can generally be installed with the rotor still in place, using a Class F epoxy glue.

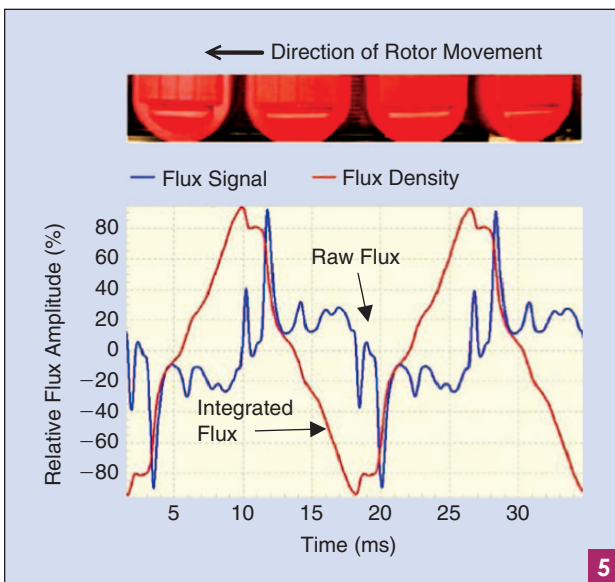
The shape of the flux signal at 0 MW, 0 Mvar. The vertical scale is the voltage output of the flux probe, while the horizontal axis is the circumferential position around the rotor.

The initial experiments with the flux monitoring system were carried out on many dozens of hydrogenerators, which generally have a large number of salient poles. An example is shown below. The voltage waveform from a flux probe is shown in Figure 5. The generator was operated at no-load conditions, 0 MW and 0 Mvar, resulting in a symmetrical shape of both the raw signal measured (blue line) and integrated values of raw voltage signal (red line). Since the shape of the signal changes with the load of the machine (Figure 6), raw data should be integrated for further processing.

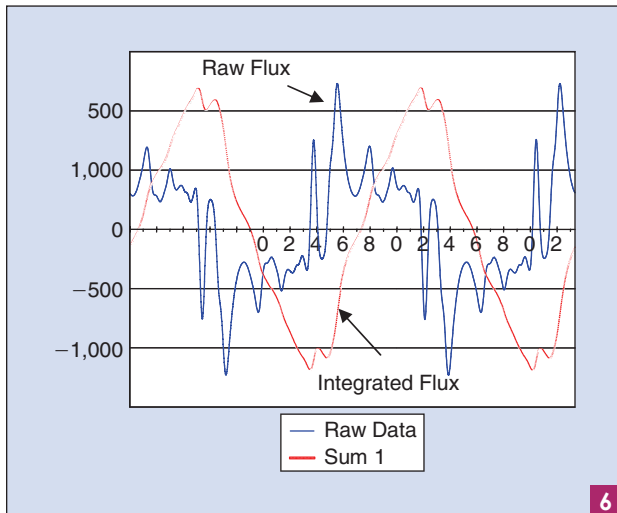
The shape of the signal at 125 MW, 0 Mvar.

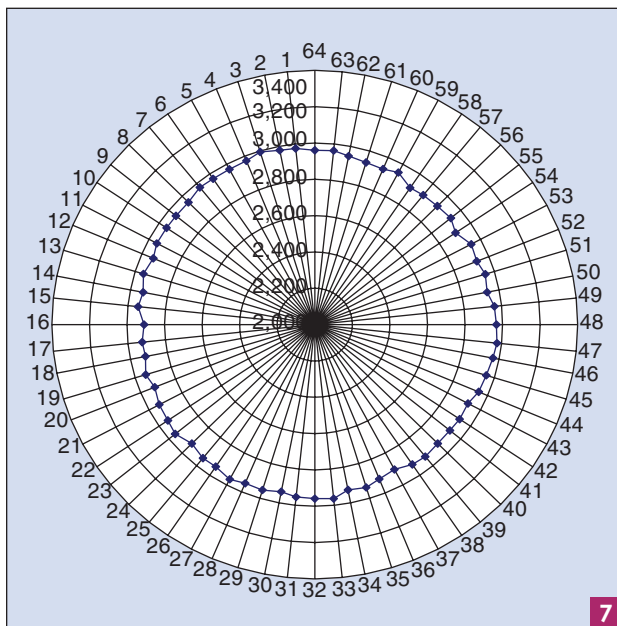
A polar flux diagram of a hydrogenerator operating at full power. The machine has 64 poles and no known shorts. The radial scale is the accentuated average flux, and the circumferential scale is the rotor pole number.

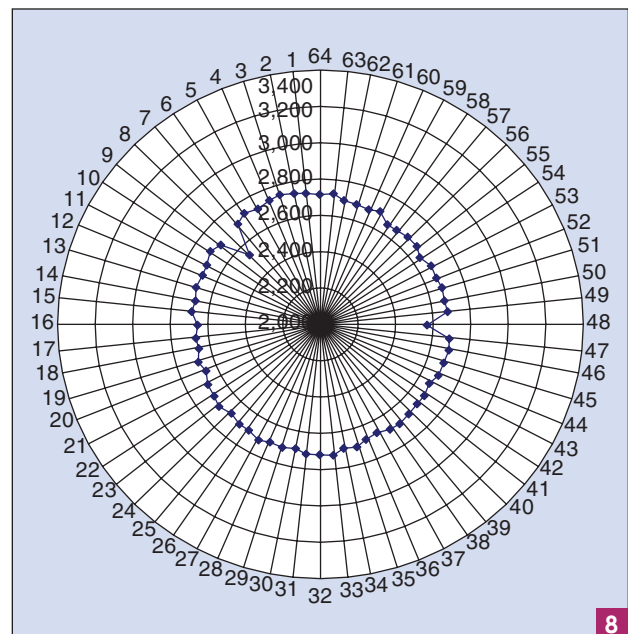
Polar diagram of a 64-pole rotor with shorts detected at poles 8 and 48.

As each pole in the rotor passes the coil, there will be a peak in the induced voltage caused by the magnetic flux from the pole. The voltage can then be recorded, and each peak of the waveform represents the average flux across one rotor pole. Any turn short in a pole reduces the effective ampere turns of that pole and thus the signal from the flux probe associated with that pole. The recorded waveform data can then be analyzed to locate the poles containing the fault as long as one has calibrated the pole location from a start location marked on the rotor shaft.

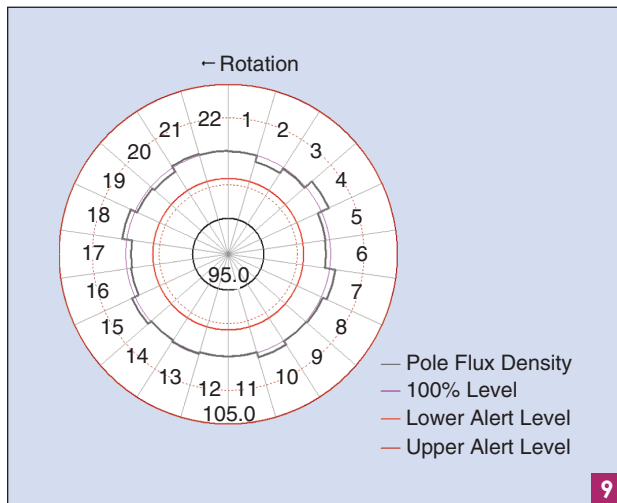
Flux plot recorded in 2006 from a 22-pole motor.

Figures 9 and 10 show the resultant flux plot from a 22-pole motor with a strip-on-edge rotor pole design. Figures 11 and 12 show the flux data from a six-pole motor. There are minor differences in the magnetic flux from each pole caused by different pole mounting (and thus slightly different air gaps). However, none of the poles has a significant enough reduction in flux to indicate that shorted turns on a pole are indicated. Figures 9–12 also indicate that the flux measurements are repeatable over time. These machines do not have increased bearing vibration, which supports the belief that there are no shorted turns. To date, none of the motors monitored shows evidence of shorted turns.

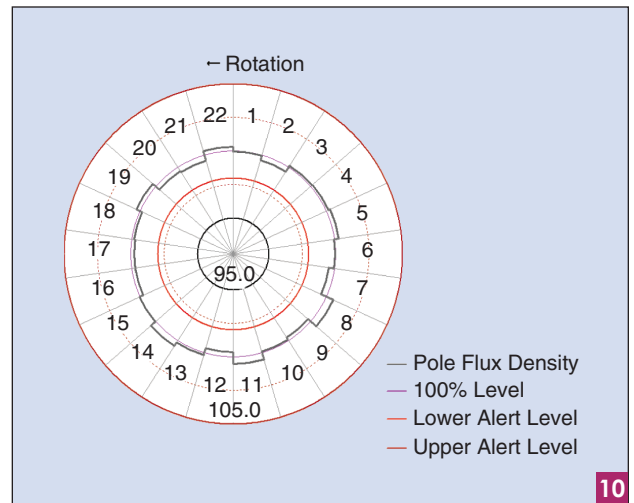
Flux plot recorded in 2011 from the same motor as in Figure 9.

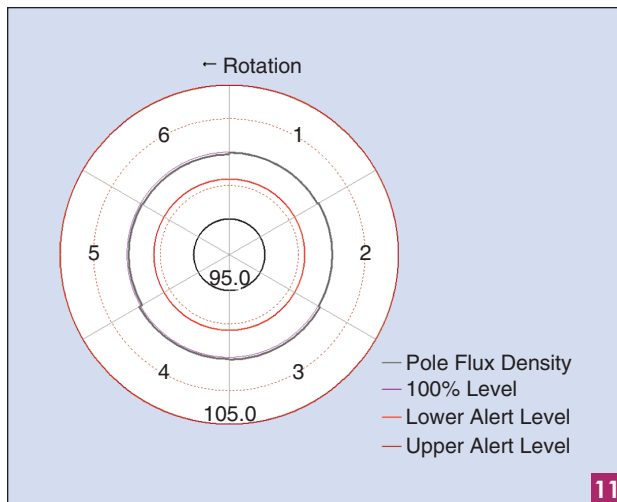
A polar plot recorded in 2007 of flux from a six-pole motor.

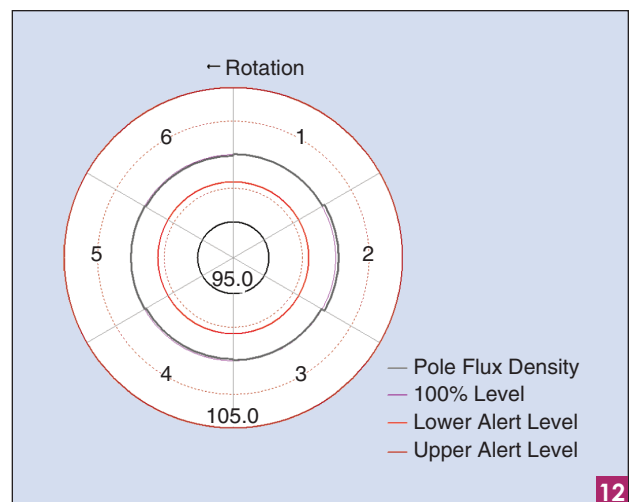
Polar plot recorded in 2011 of the same motor as in Figure 11.
