USING MAGNETIC FLUX MONITORING TO DETECT SYNCHRONOUS MACHINE ROTOR WINDING SHORTS

Copyright Material IEEE
Paper No. PCIC-2011-17

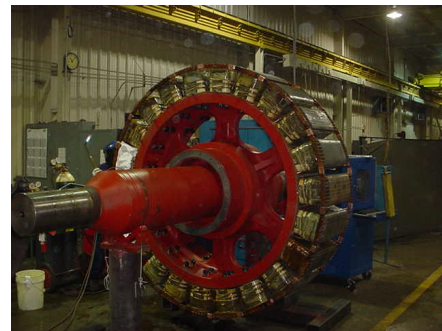
Fig. 1 Rotor from a salient pole synchronous motor

Most of the synchronous motors used in the air separation business have salient pole rotor windings having 4 to 26 poles. Each field pole is an electromagnet, and the rotor winding is made by mounting the poles in pairs on the rotor rim. The poles are then electrically connected to the DC supply (normally up to a few hundred volts) in such a way as to create alternating north and south poles around the rim. Each field pole consists of laminated steel core, which looks rectangular when viewed from the rotor axis. Around the periphery of each pole core are the copper windings. Fig. 1 is a photo of a rotor from a 20-pole salient pole synchronous motor.

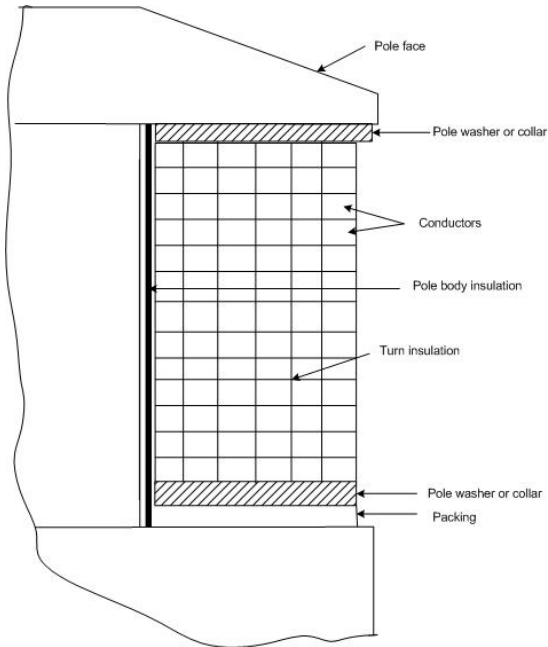
Fig. 2 Multi-layer wire wound design

There are two basic types of salient pole designs [1]. The older type of field pole design, and still the design used on motors less than a 1000 HP or so, is called the multi-layer wire wound type. In this design, magnet wire is wrapped around the pole (Fig. 2). The magnet wire usually has a rectangular cross section, and many hundreds of turns are wound on the pole, several magnet wire layers deep. The turn insulation is the magnet wire insulation. Looking from the axial direction, the laminations are shaped to have a pole tip (which is the part of the rotor pole which is closest to the stator) to support the winding against the centrifugal force. Insulating washers and strips are placed between the magnet wire and the laminations to act as the ground insulation.

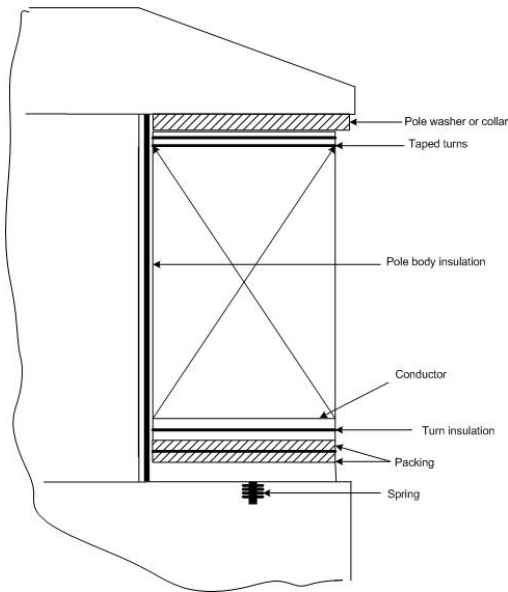
Fig. 3 Copper "strip on edge" salient pole design

For larger machines, the 'strip-on-edge' design is favored since it can be made to better withstand rotational forces. In this case a thin copper strip is formed into a 'picture frame' shape, so that the 'frame' can be slid over the pole laminations (Fig. 3). Laminated insulating separators (made from epoxy glass laminates or Nomex™ materials) act as turn insulation to insulate each copper 'frame' from one another. On some copper 'frames', especially those near the pole face, an insulating tape may be applied to the copper strip to increase the creepage distance. The tape and separators form the turn insulation, and the copper 'picture frames' are connected in series to make the coil. As with the multi-layer design, the winding is isolated from the grounded pole body by insulating washers and strips (Fig. 3). Often the entire pole may be dipped in an insulating liquid to bond the various components together.

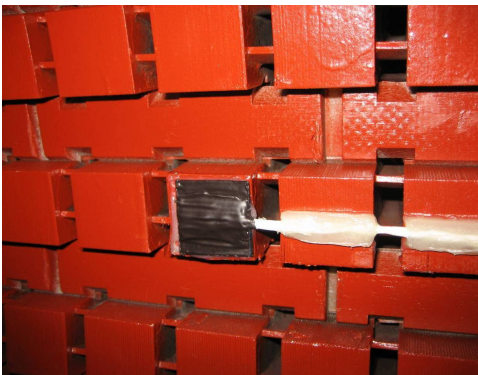
Fig. 4 Flux Probe (black) mounted on a stator core tooth, with connecting lead (white)

Rotor flux monitoring involves measuring the magnetic flux in the generator or motor air-gap to determine if field winding shorts have occurred in the rotor poles. The radial magnetic flux from the rotor is detected by means of a coil or “probe” consisting of several dozen turns that is glued to a stator core tooth (Fig. 4). As each rotor pole sweeps by the flux probe, a voltage is induced in the coil that is proportional to the flux from the pole that is passing the coil. The voltage is measured by electronic instruments. In a salient pole machine, the radial magnetic flux profile across each rotor pole depends on the MW and MVAR loading of the machine. After corrections for variations in the air-gap, any change in the flux profile within a pole at a given load must be due to shorted turns.

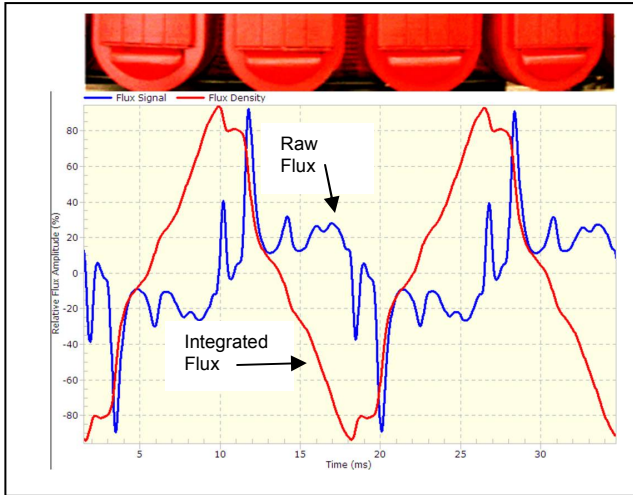
←direction of rotor movement

Fig.5 Shape of the flux signal at 0 MW, 0 MVAR. The vertical scale is the voltage output of the flux probe while the horizontal axis is the circumferential position around the rotor.

The initial experiments with the flux monitoring system were carried out on many dozens of hydrogenerators which generally have a large number of salient poles. An example is shown below. The voltage waveform from a flux probe is shown in Fig. 5. The generator was operated at no load conditions, 0 MW and 0 MVAR, resulting in a symmetrical shape of both the raw signal measured (blue line) and integrated values of raw voltage signal (red line). Since the shape of the signal changes at different loads of the machine (Fig.6), raw data should be integrated for further processing.

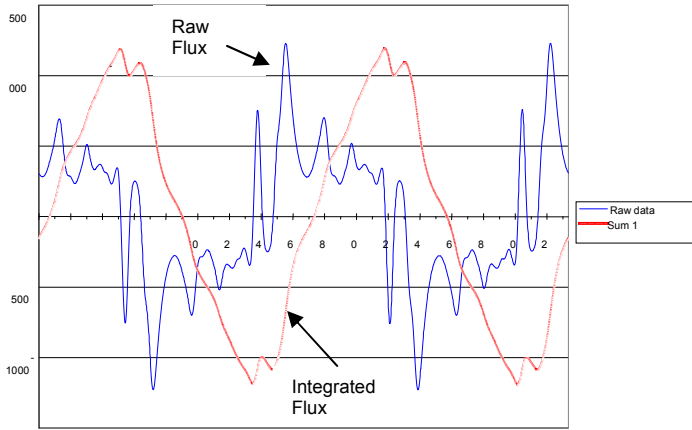
Fig. 6 Shape of the signal at 125 MW, 0 MVAR

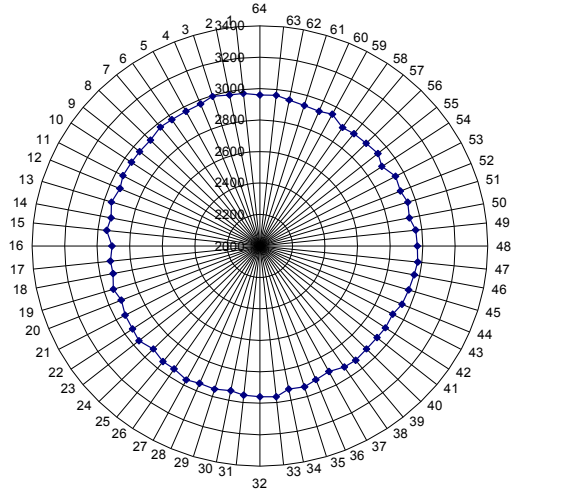
Fig. 7 Polar flux diagram of a hydrogenerator operating at full power. The machine has 64 poles and no known shorts. The radial scale is the accentuated average flux and the circumferential scale is the rotor pole number.

Given that change in the flux profile within a pole at a steady load must be due to shorted turns, comparison of one pole to another can be used as an indication of shorted turns. The transformed flux data can then be shown as a polar plot (Fig. 7). Minor differences between poles and rotor or stator eccentricity will result in a less than perfect circle.

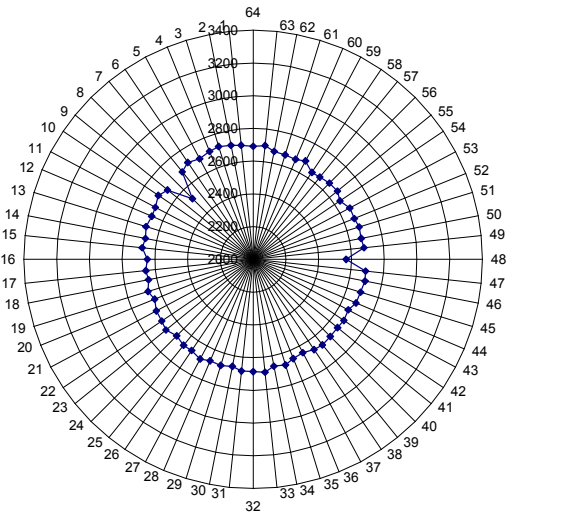
Fig. 8 Polar diagram of 64 pole rotor with shorts detected at poles 8 and 48

Fig. 8 is the result from the same 64 pole rotor with temporarily applied shorts on poles 8 and 48. The poles with shorted turns are clearly determined by the lower flux magnitude at these poles.

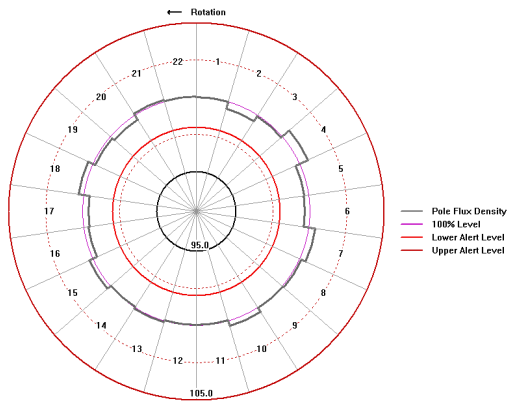
Fig. 9 Flux plot recorded in 2006 from a 22 pole motor

In 2004 flux probes were installed on seven stator cores of salient pole motors used to drive compressors for air separation processes. These motors had from 6 to 22 poles. Figs. 9 and 10 show the resultant flux plot from a 22 pole motor with a strip-on-edge rotor pole design. Figs. 11 and 12 show the flux data from a 6-pole motor. There are minor differences in the magnetic flux from each pole caused by different pole mounting (and thus slightly different air gaps). However, none of the poles has a significant enough reduction in flux to indicate that shorted turns on a pole are indicated. Figures 9 to 12 also indicate the flux measurements

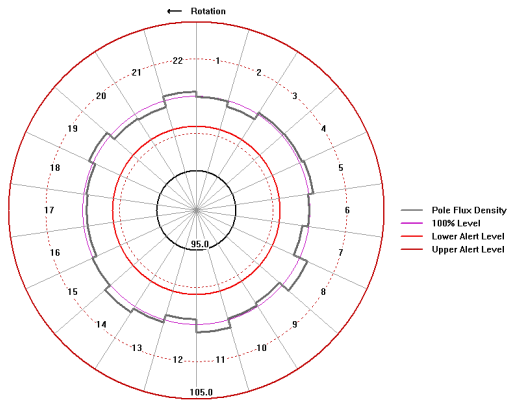
Fig. 10 Flux plot recorded in 2011 from the same motor as Fig. 9

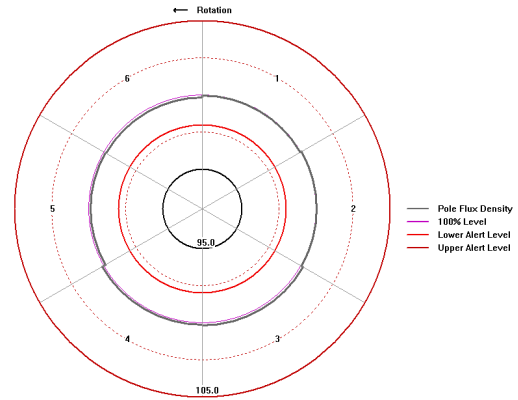
Fig. 11 Polar plot recorded in 2007 of flux from a 6 pole motor.

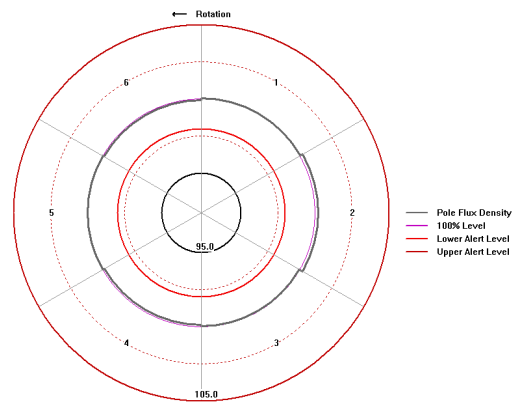
Fig. 12 Polar plot recorded in 2011 of the same motor as Fig. 11
