Using Diagnostic Technology for Identifying Generator Winding Maintenance Needs

Detecting deterioration in generator winding insulation can help hydro O&M staff plan needed maintenance. One approach is analyzing the partial discharge (small electrical sparks) activity in the insulation; the more of this activity, the closer the winding is to failure. Instruments are available for measuring partial discharge during normal generator operation. Ontario Hydro is saving millions of dollars in avoided rewinds using this approach.

By John F. Lyles, T. Earl Goodeve, and Gregory C. Stone

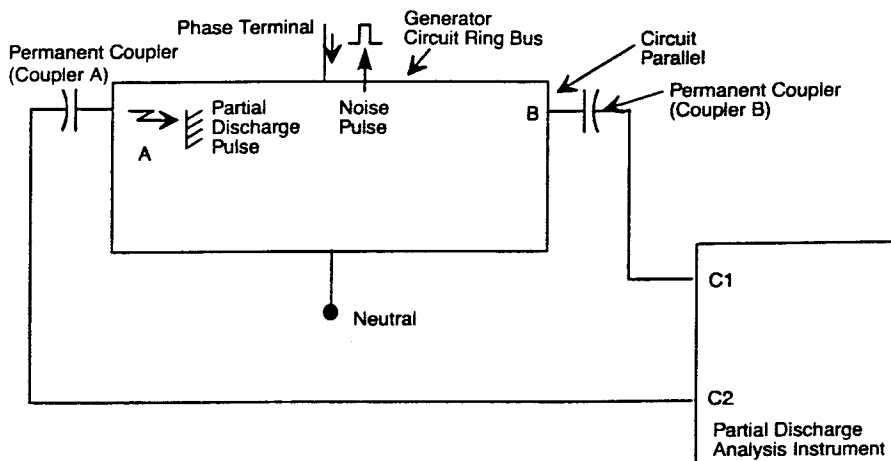
This figure illustrates how high voltage 80 pF capacitive couplers are installed in a generator stator winding. The couplers, shown here as A and B, usually are installed at the connection point of the generator circuit ring bus to the coils. C1 and C2 are the input terminals of the PDA instrument.

The unique feature of the partial discharge analysis (PDA) test is its ability to ignore other pulse-type electrical signals that can be confused with stator partial discharges. When a partial discharge occurs, a current pulse lasting only a few nanoseconds results. The current pulse causes a voltage pulse to propagate through the stator winding. In the PDA test, special high voltage 80 pF capacitive couplers are installed in the winding, usually at the connection point of the generator circuit ring bus to the coils. At least two couplers are installed per phase, at each end of the circuit ring bus. Arrangement of the couplers is shown in the figure below.

When a partial discharge pulse occurs, for example, near coupler A, the associated voltage pulse is immediately detected at coupler A. However, the pulse takes up to 50 nanoseconds to travel around the circuit ring bus to coupler B. The PDA instrument detects that the pulse arrived at the couplers at different times, and digital electronics identify the pulse as a partial discharge from A.

An electrical noise pulse (such as from corona on the generator output transformer) comes into the generator and travels along the circuit ring bus to both A and B couplers. If the circuit ring bus is the same length between the generator terminal and the coupler sites, the noise pulse is detected at the same time by both couplers. The PDA instrument detects this simultaneous arrival of the pulse, and defines the signal to be due to noise. Thus, noise is characterized by simultaneously arriving pulses, whereas stator winding partial discharge results in pulses arriving at significantly different times at the two couplers. There are many complications in hydro generators; however, methods have been developed by several PDA test manufacturers that enable the detection and, for the most part, elimination of noise on most hydro generators rated 10 MW or more.

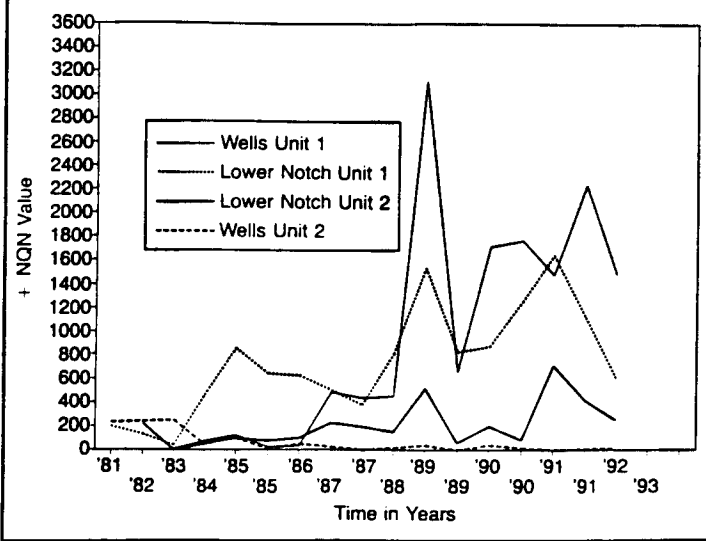
Figure 1: This plot shows the trend in positive total partial discharge activity (NQN) for four generators at the 232-MW Wells and 270-MW Lower Notch generating stations. The CRTV (conductive room temperature vulcanizing) injection and rewedging repair in 1975 for Lower Notch Unit 2 and Wells Unit 2 has been more successful (as demonstrated by lower partial discharge activity) than the earlier repairs to the other units.

have epoxy-mica windings and are rated 120 MVA. The first 11 years of partial discharge monitoring of these units, after *in situ* repairs for loose windings in 1975, indicated satisfactory results. However, beginning in 1988, Unit 1 at both stations became significantly worse in terms of partial discharge activity, as seen in Figure 1. Interpretation of PDA data, coupled with detailed knowledge of physical construction and visual inspection of the units, confirmed that the major source of partial discharge activity in the units was restricted to the first five bottom stator bars at the high-voltage end of the winding in one of the circuits. Because these bars were in the bottom of the stator slots, it is likely that the 1975 repair procedure was much less effective than for the rest of the winding owing to difficult access. The deterioration of these bars apparently was caused by significant slot discharges occurring due to semiconducting coating deterioration.

Because Lower Notch and Wells operate as base load plants, Ontario Hydro is choosing not to shut them down for an outage (and consequently spill water) until the ozone concentrations in the powerhouses exceed the U.S. Occupational Safety and Health Administration (OSHA) limits, or until a stator winding bar failure occurs.
