# Iris Power MDSP3

Detecting motor rotor cage-winding faults and air gap eccentricity

## A Third Generation On Line Tool to Find Broken Rotor Bars and Rotor Air Gap Eccentricity in Induction Motors

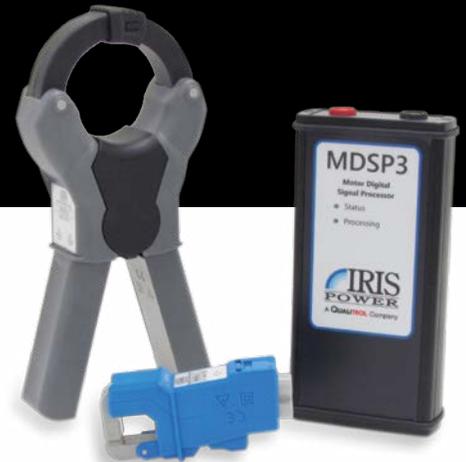
MDSP3 with 2 CTs

**Range and accuracy:** Iris Power MDSP3 can accurately test motors under varying load conditions where many other test systems give ambiguous results. The Iris Power MDSP3 uses two current probes to cover a wider range of current from 5A to 1000A.

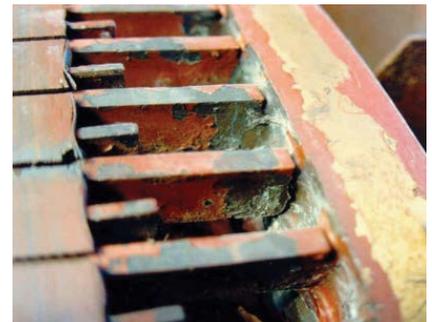
Broken rotor bar

**Rotor bar movement and failure:** Broken rotor bars can lift out of the rotor slot due to centrifugal force or pieces of them can break off and cause a stator winding failure.

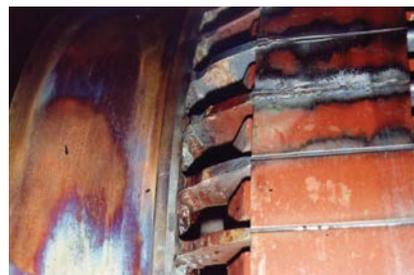
Rotor core damage due to broken bars

**Rotor Core damage:** Broken bars cause local temperature increases and arcing leading to rotor core damage.

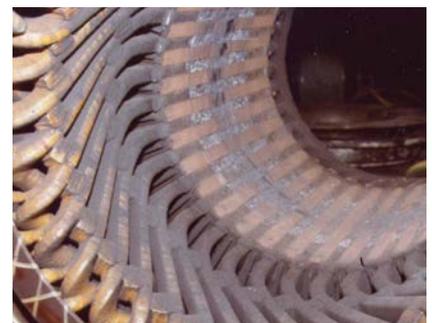
Stator rub due to eccentricity

**Rotor eccentricity:** For the rotor rotating off center, both static and dynamic eccentricity in conjunction with the resulting unbalanced magnetic pull can lead to: 1) high vibration levels from rotor unbalance, 2) a rotor to rub against the stator bore which can cause a stator winding failure.
